Manhole Inspection Summary

Manhole # S09WW1019MH

Insp Date: **7/29/06 8:28 AM**

Location Address: **2702 W ROGERS AVE**

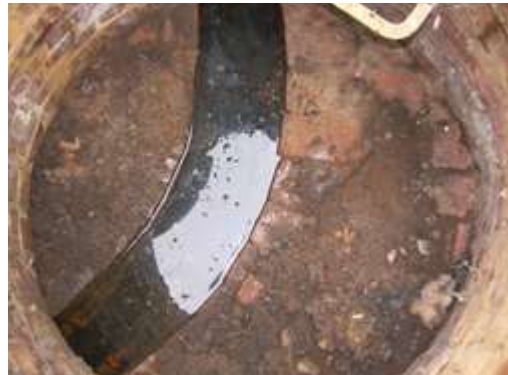
Top View

Evidence of surcharge - Bench debris.
Channel debris.

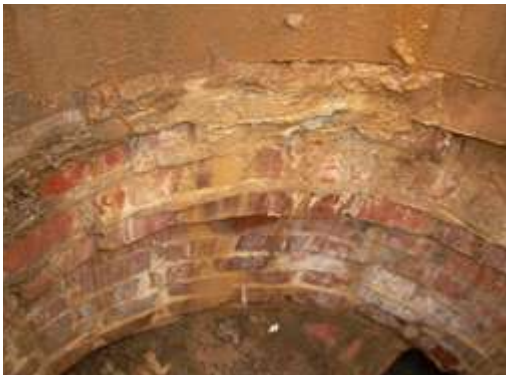
Defect

Frame leaks. Corbel deterioration and infiltration. Barrel infiltration.

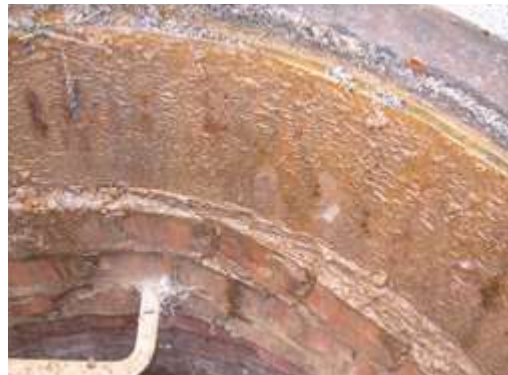
Defect

Frame leaks. Corbel deterioration and infiltration.

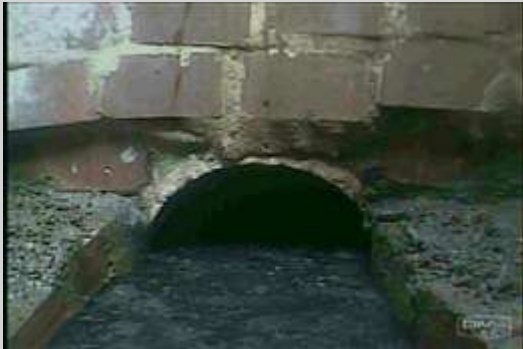
8 in. Circular Gravity Sewer Pipe Out @ 12 O'Clock

Deposits: ☐ None ☒ **Mud** ☐ Sludge ☒ **Debris** ☐ Grease

Silt Depth: **2** (in.) Deposits Extent: **Medium**

Infiltration: **Evidence** Pipe Seal Cond: **Unknown**

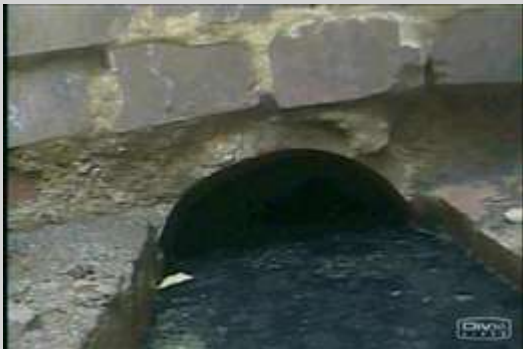
8 in. Circular Gravity Sewer Pipe In @ 7 O'Clock

Deposits: ☐ None ☒ **Mud** ☐ Sludge ☒ **Debris** ☐ Grease

Silt Depth: **2** (in.) Deposits Extent: **Medium**
